Brittany House Surveys

Thermal imaging case study.

May 2017.

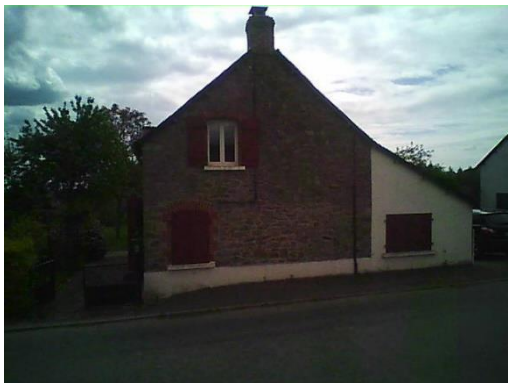
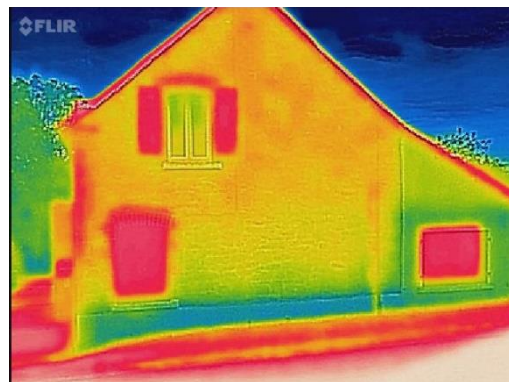
Traditional French house (late 19th century) with modern extension, right.

Traditional construction has no barrier Damp Proof Course (DPC), but employs vapour permeable mortars, such as lime to dissipate ground source moisture.

Modern construction uses pre-cast 'con blocks' in gypsum and cementitious render which is not vapour permeable and retains moisture.

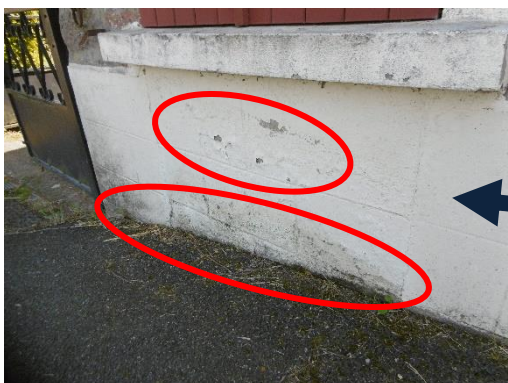
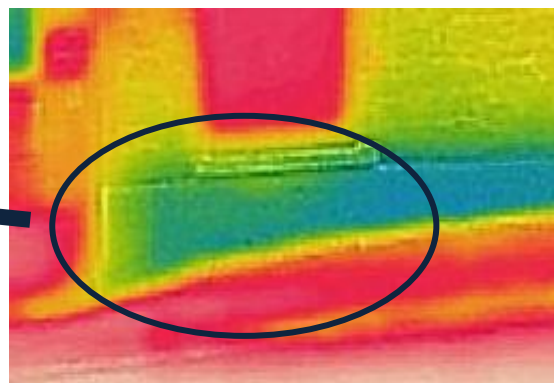
Thermal images are of temperature only. Note render dressing to base of original wall.

Visual evidence of damp (circled red).

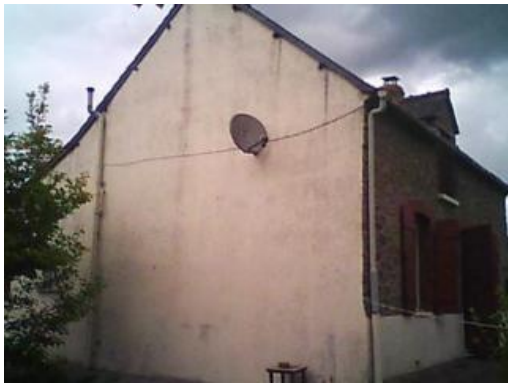
South-facing wall (rendered).

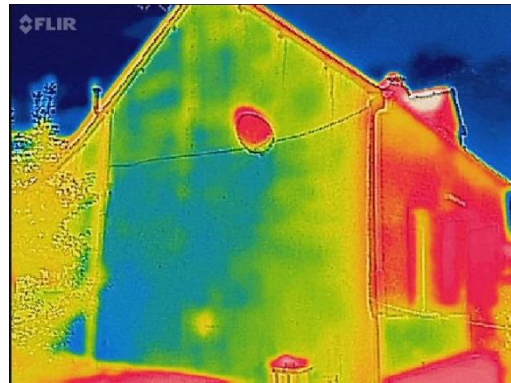
Note contrast with east-facing traditional wall.

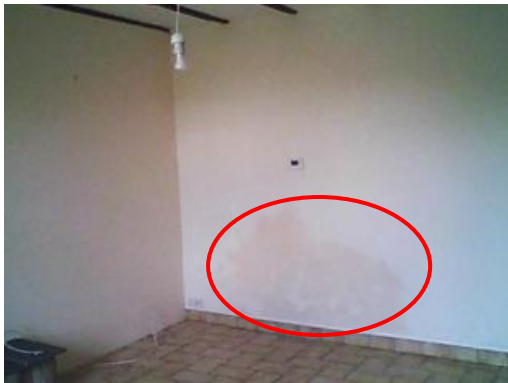
Visual evidence – damp stain (circled red).

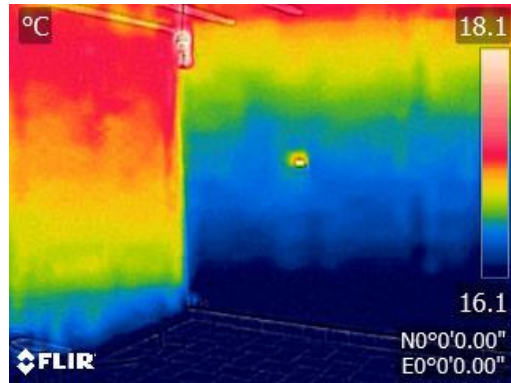
Thermal image – wall at left is panelled.

Note heat signature around central heating control box and cold effect to base of plasterboard panel wall.

Note also that temperature range to thermal image is only 2 degrees centigrade – ambient air temperature at time of image was +/- 19c.

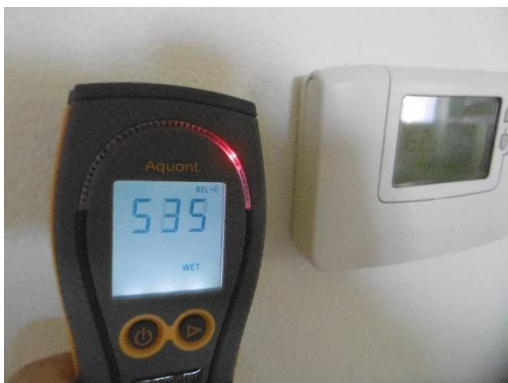
Ultrasound reading of relative humidity to wall in area adjacent to central heating control box – reference point.

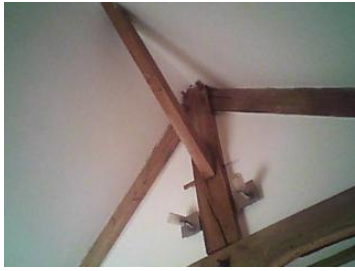
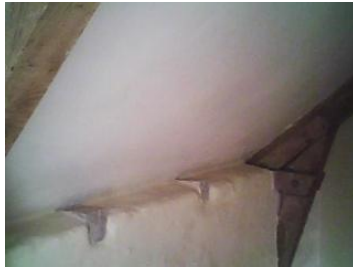
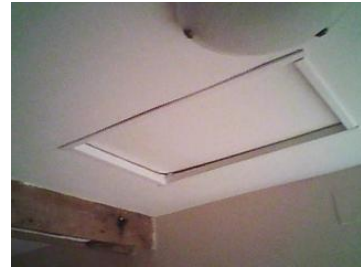
Missing insulation to roof void and pitch.

Heat leaks around hatch.
